Non-Potable Water Systems: Unique Plumbing Code Considerations

Phillip White, City of Vancouver
Manager, Plumbing & Mechanical Inspections

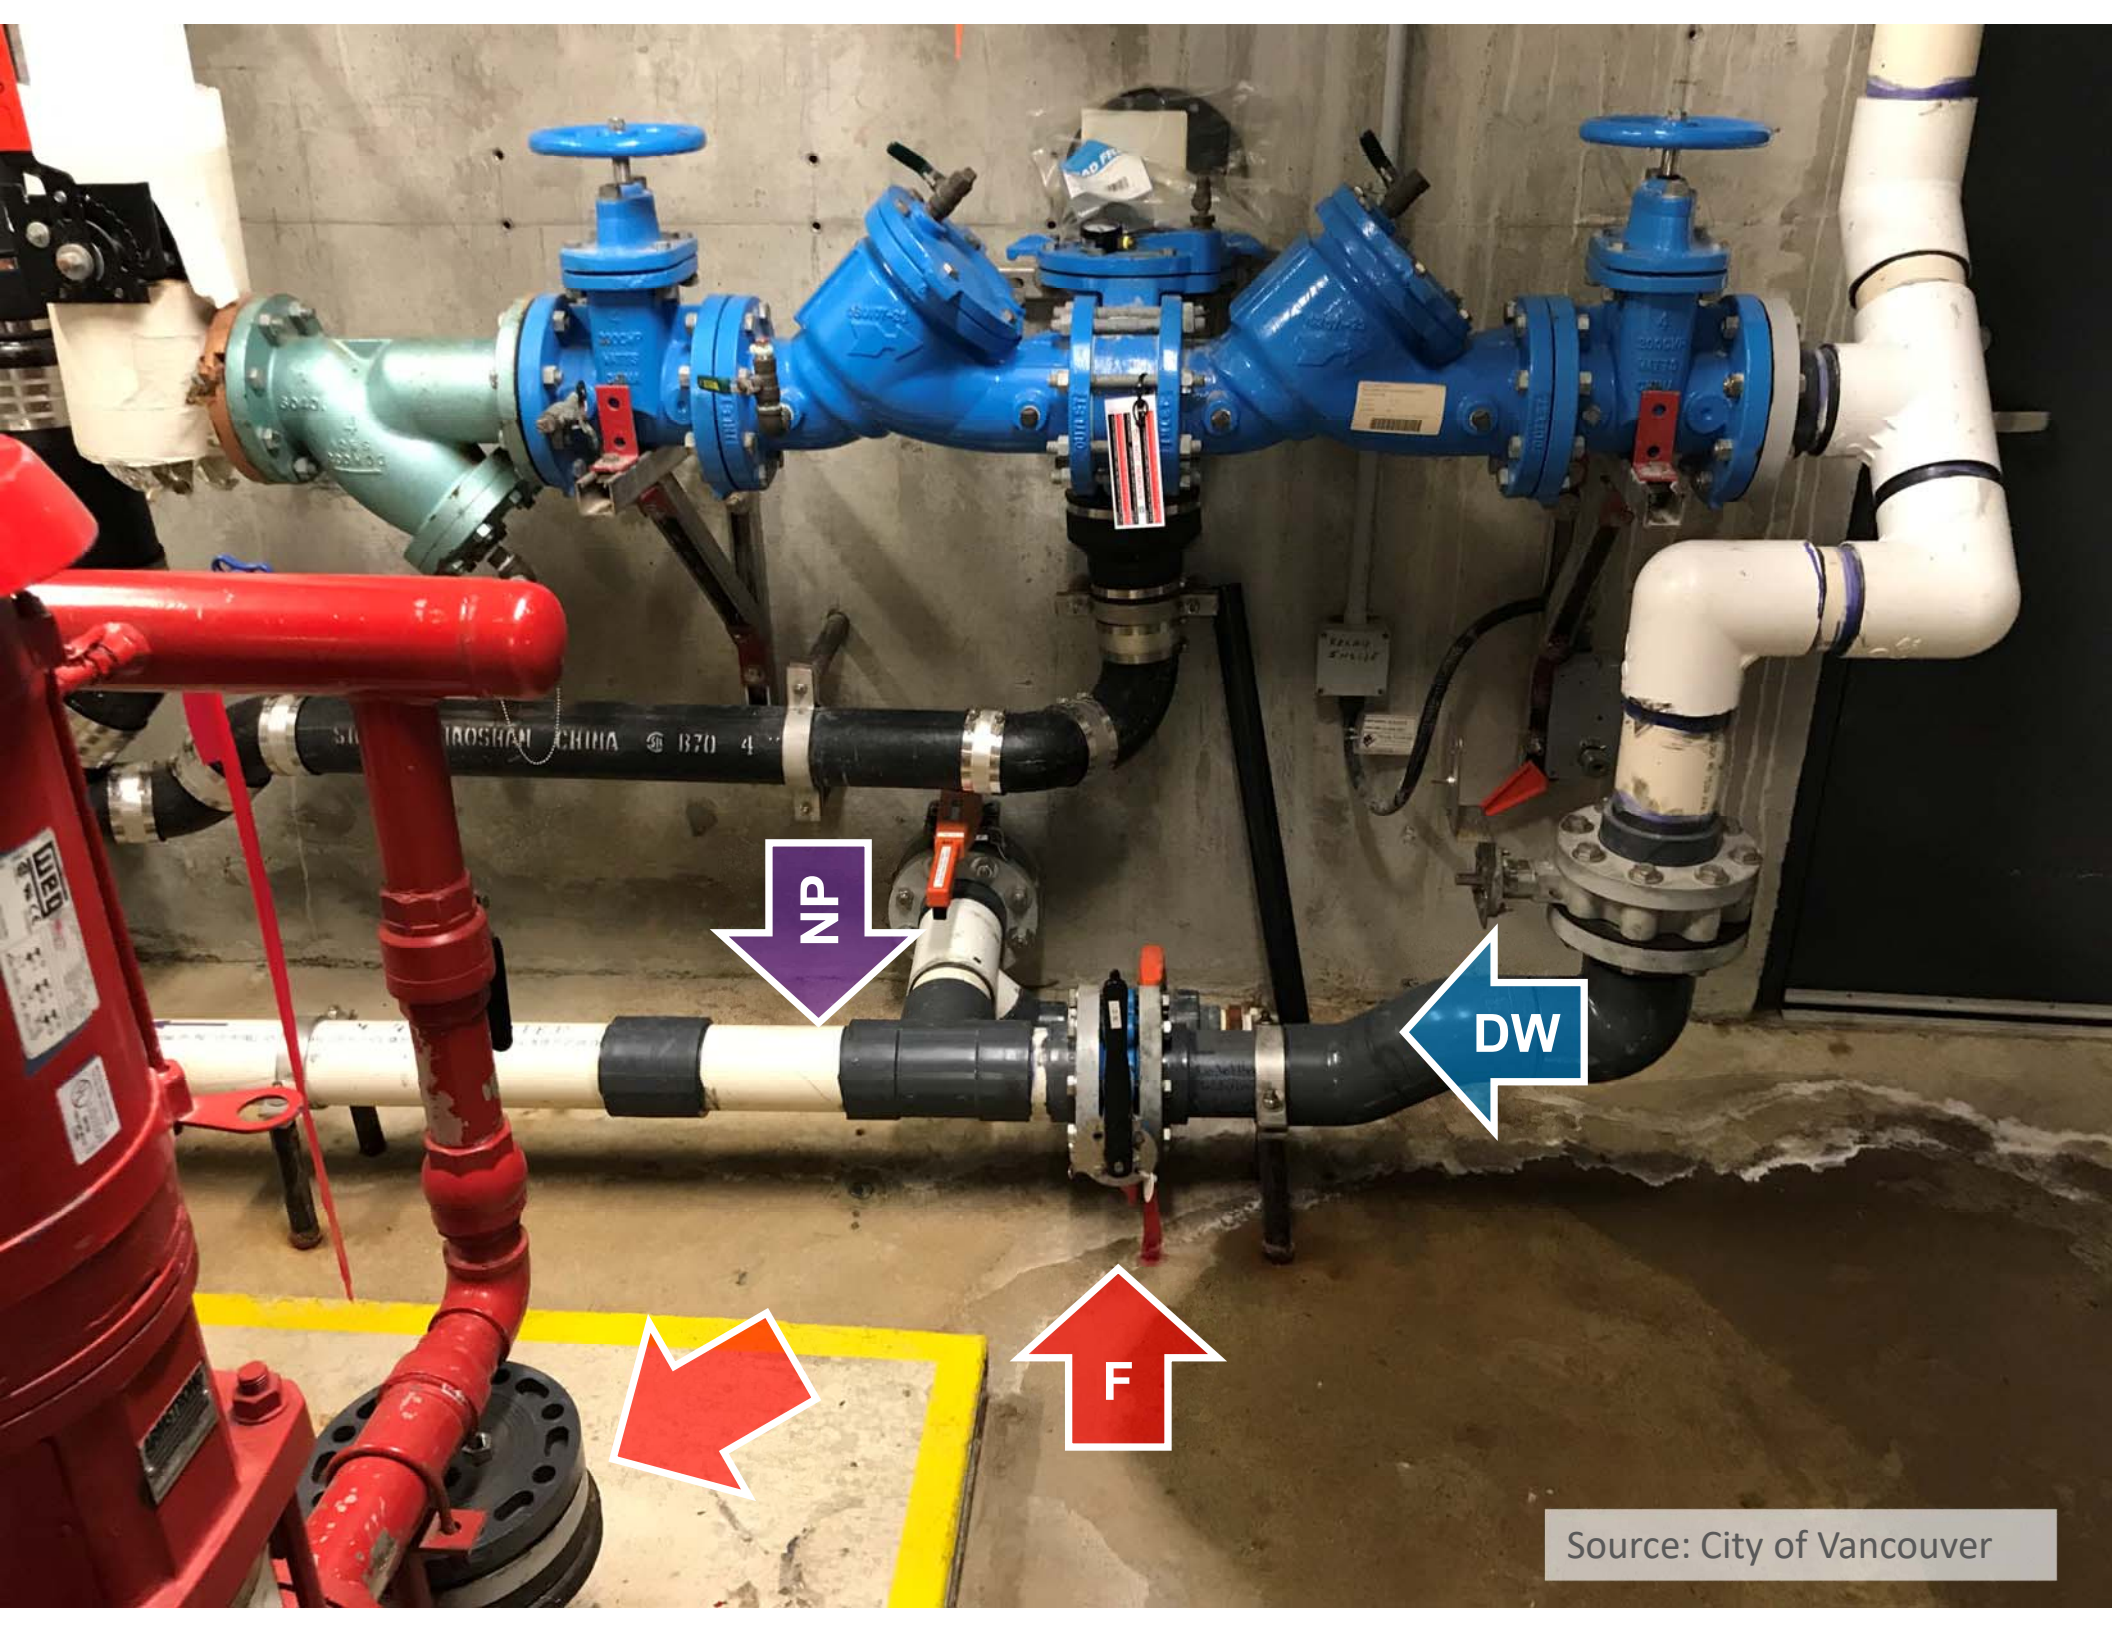
NP

DW

F

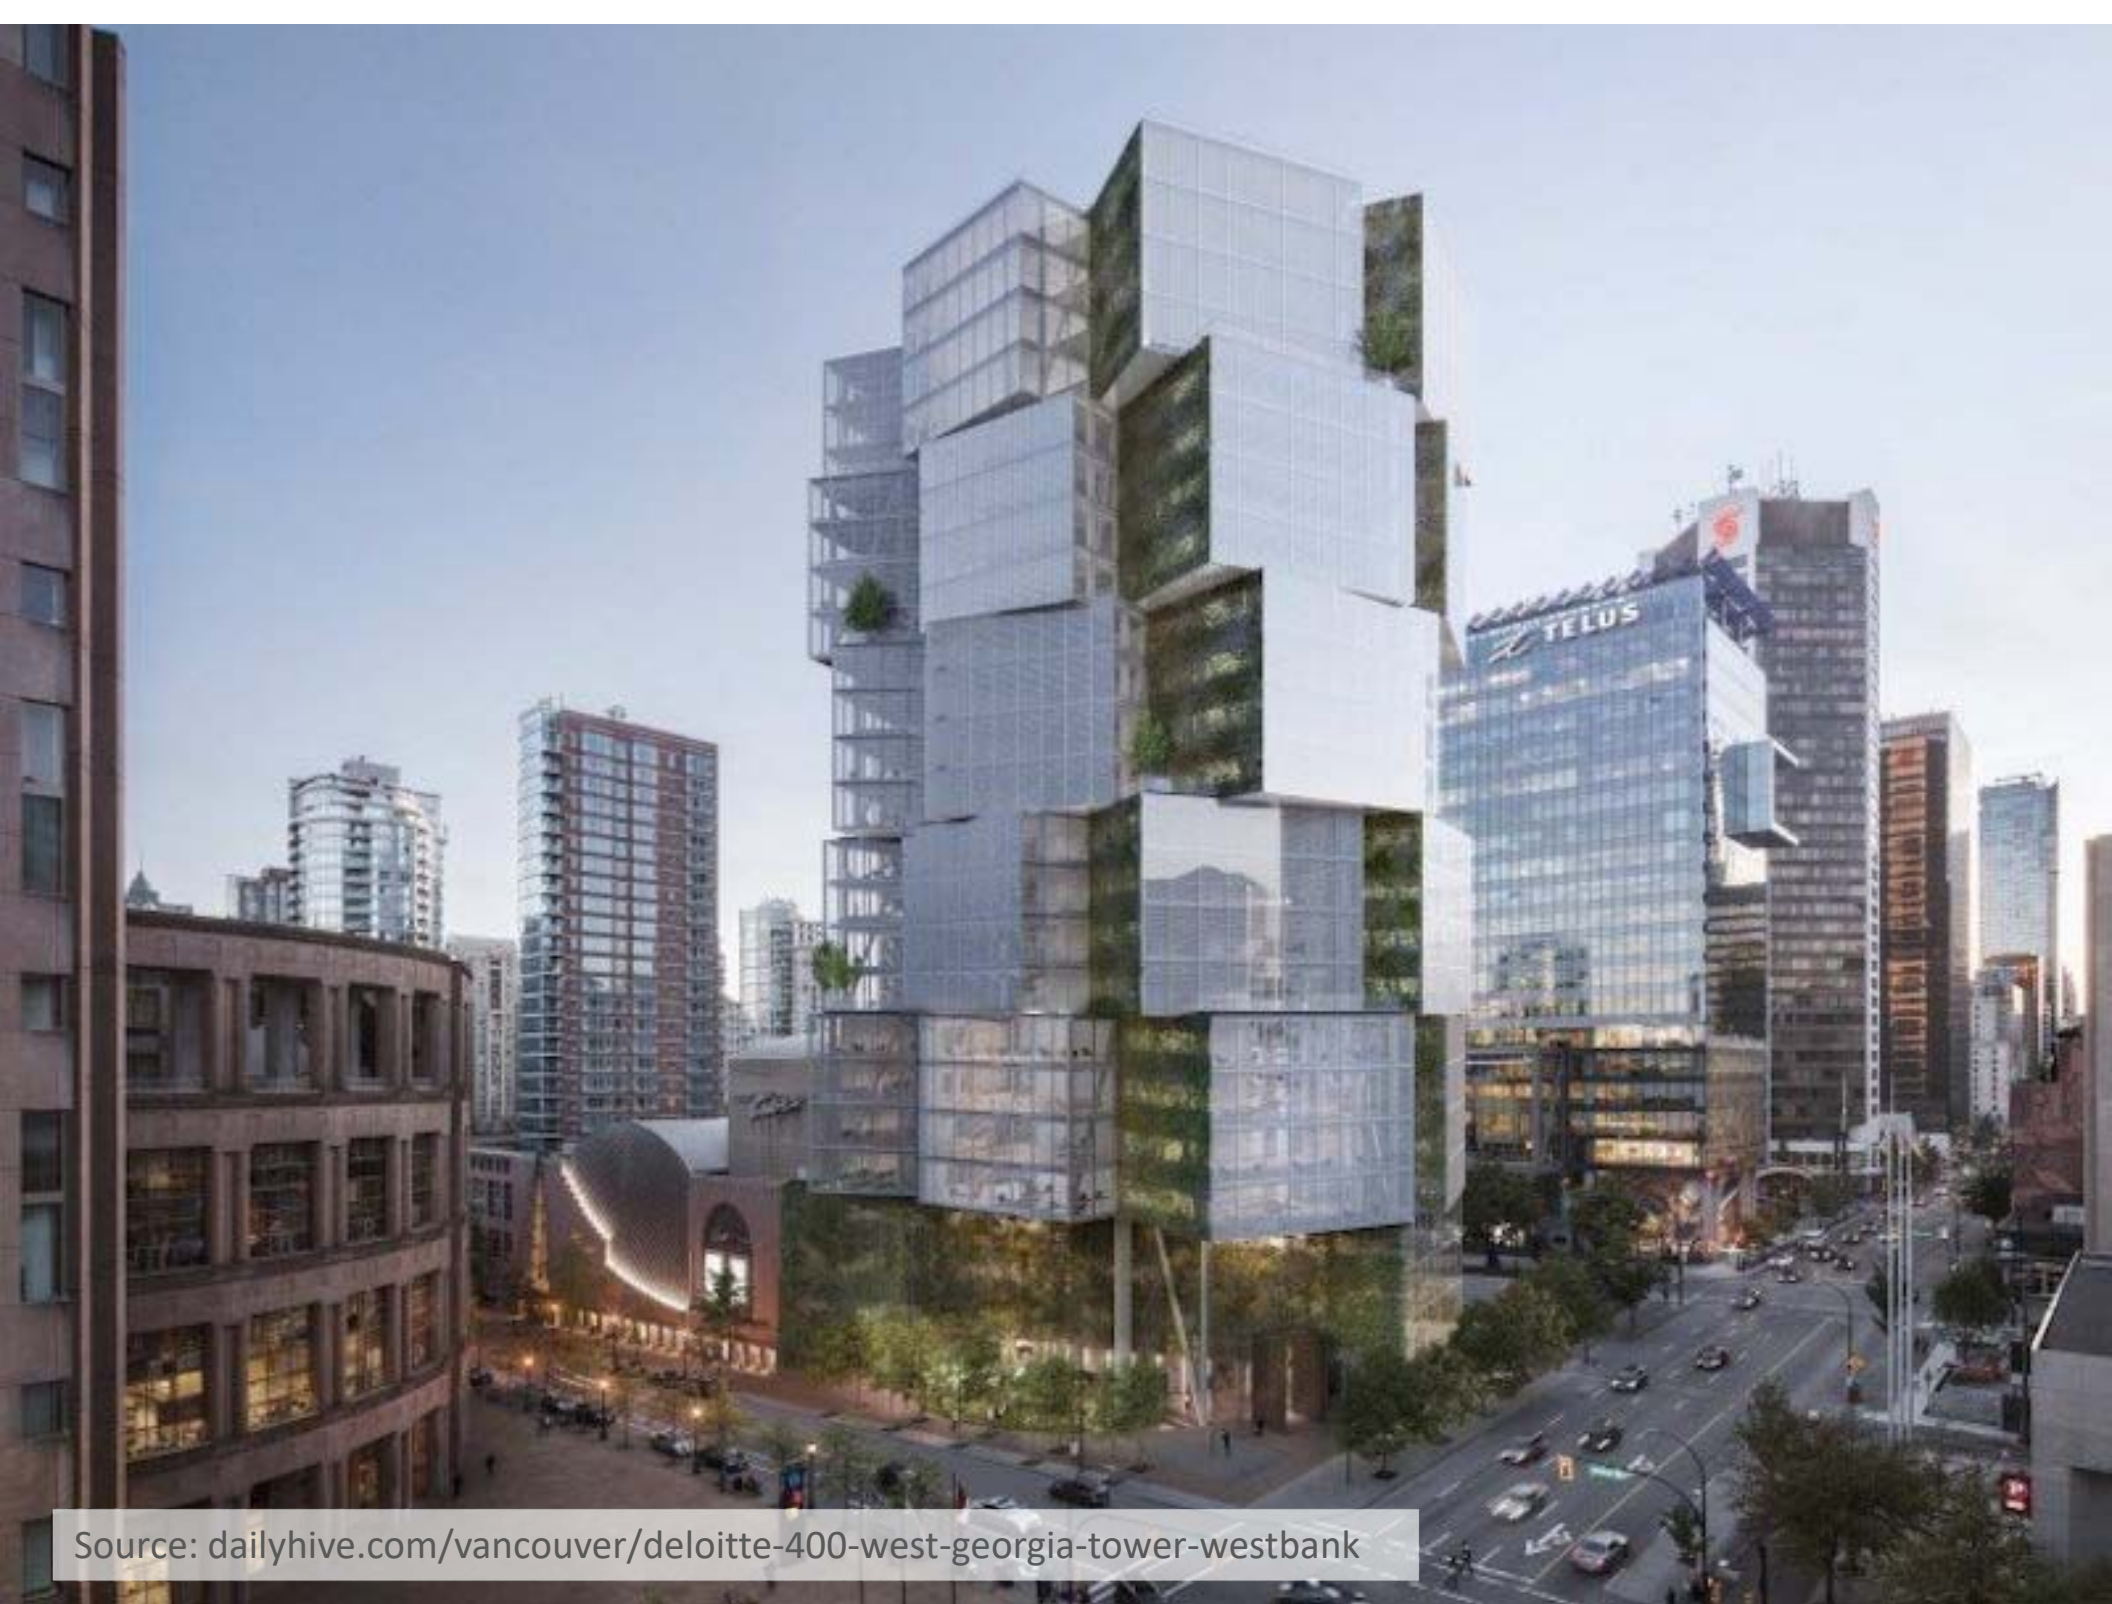
Source: dailyhive.com/vancouver/deloitte-400-west-georgia-tower-westbank

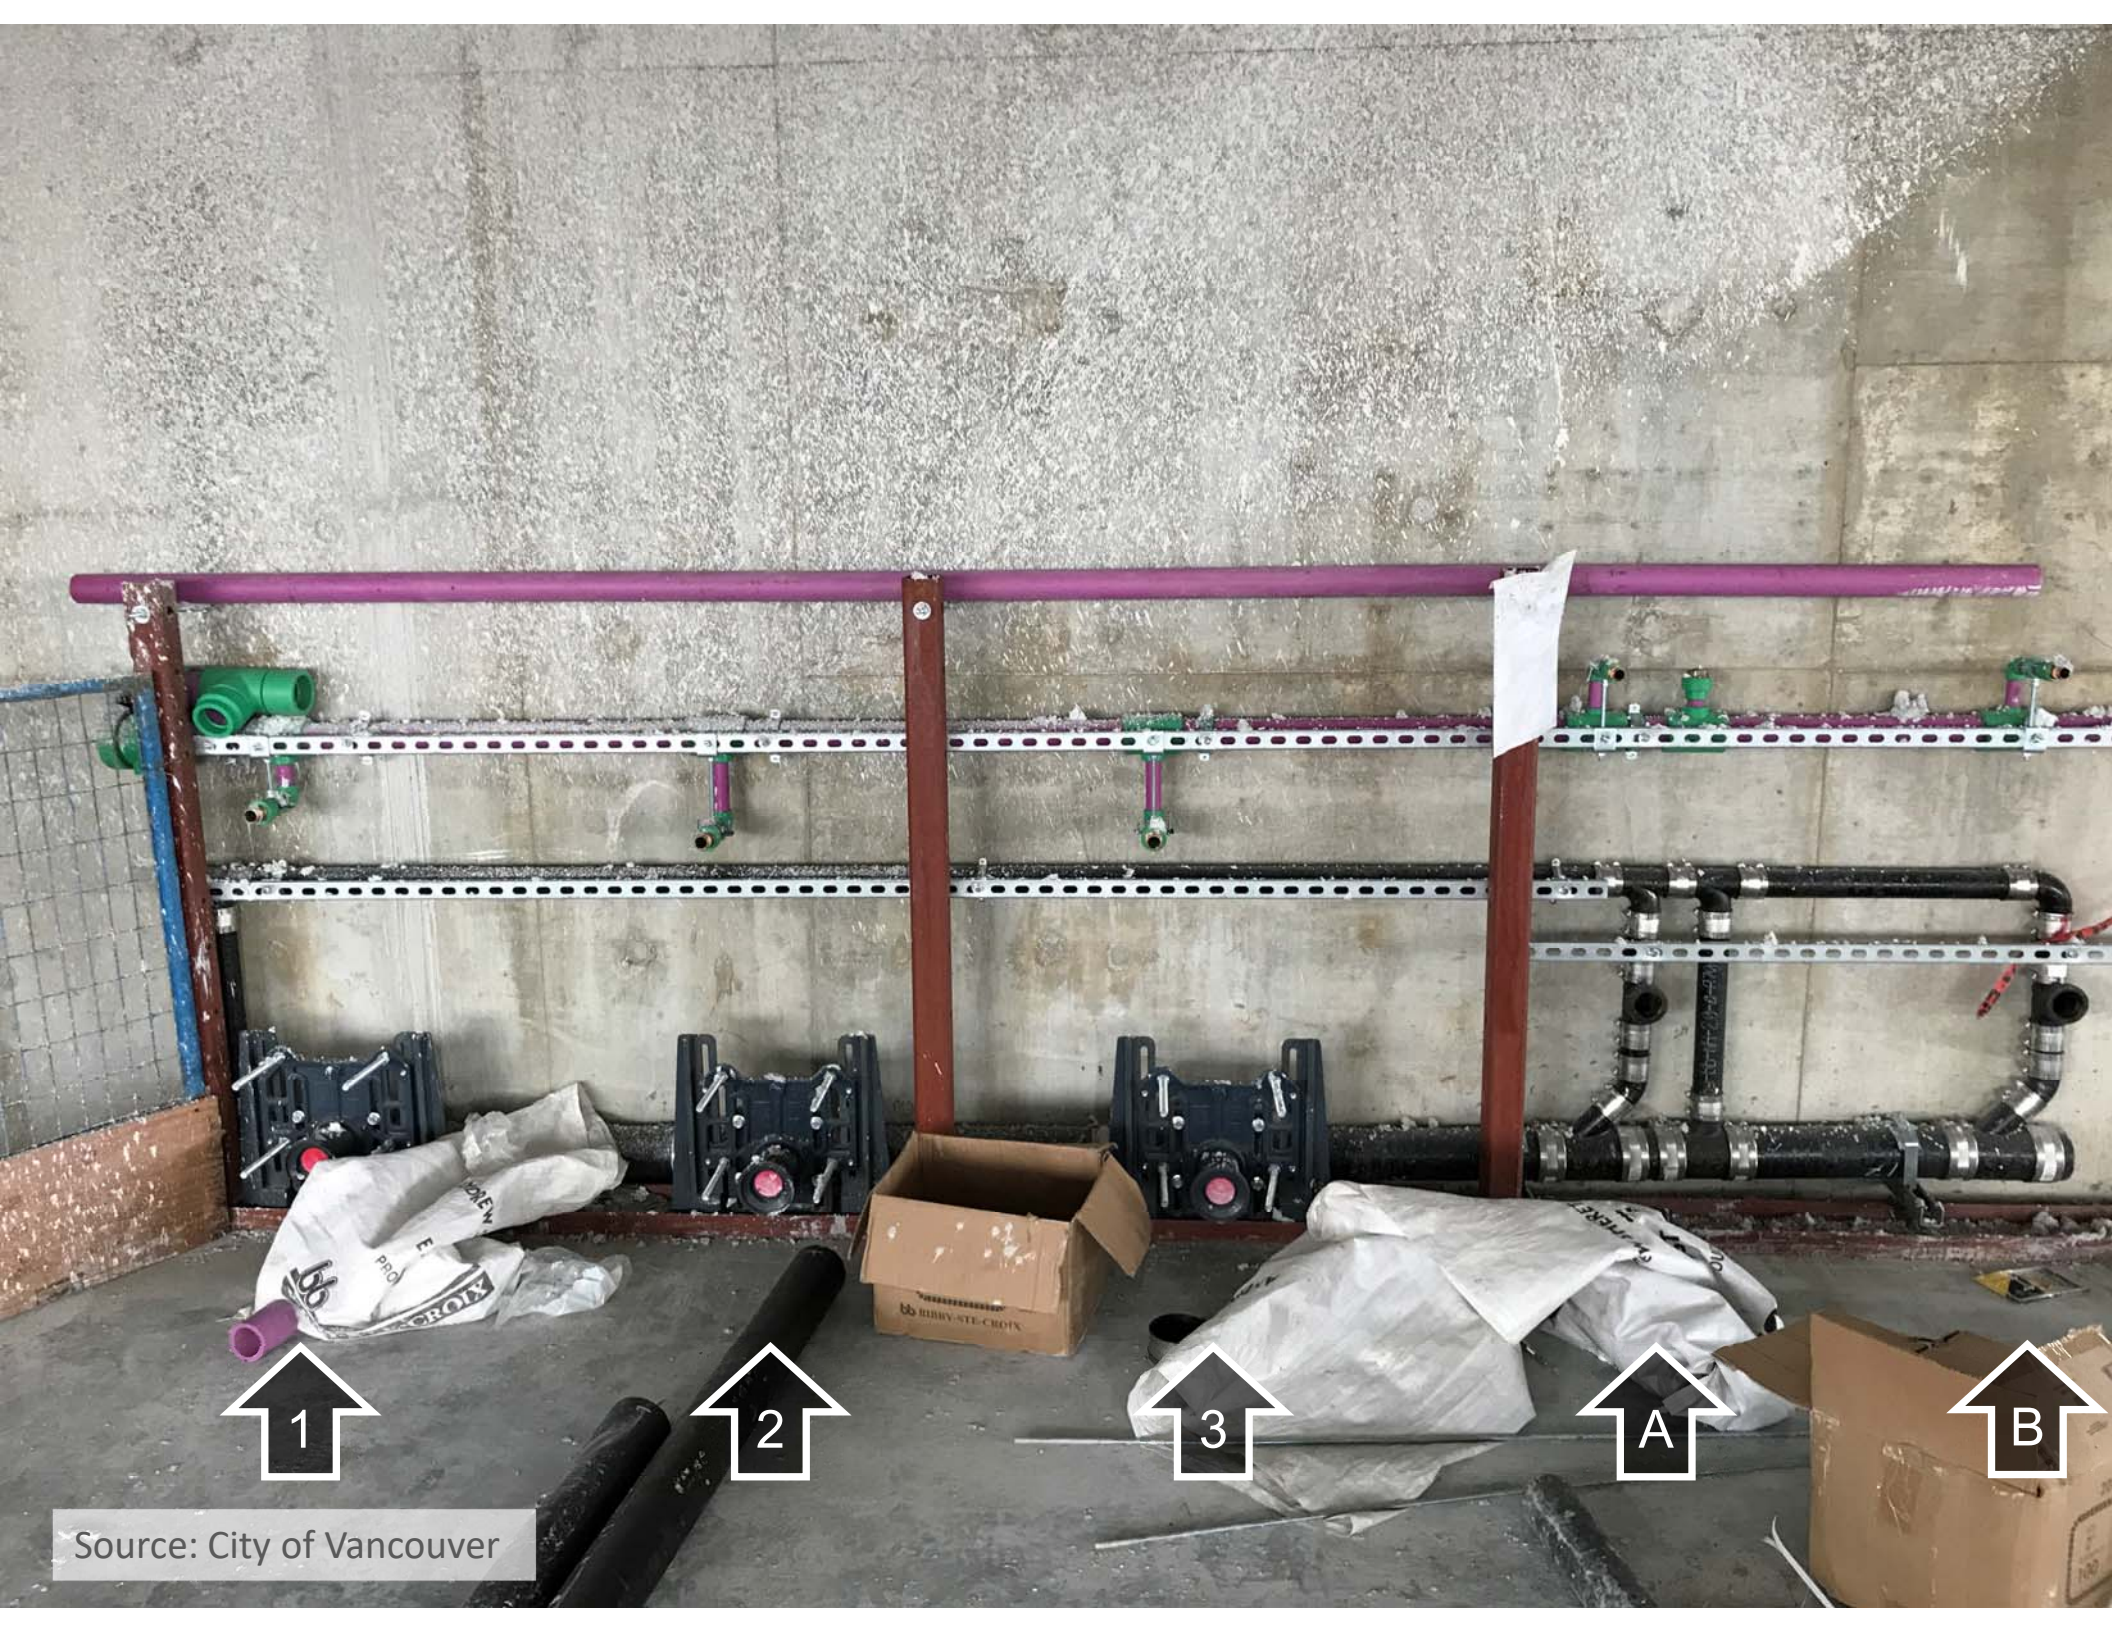
1

2

3

A

B

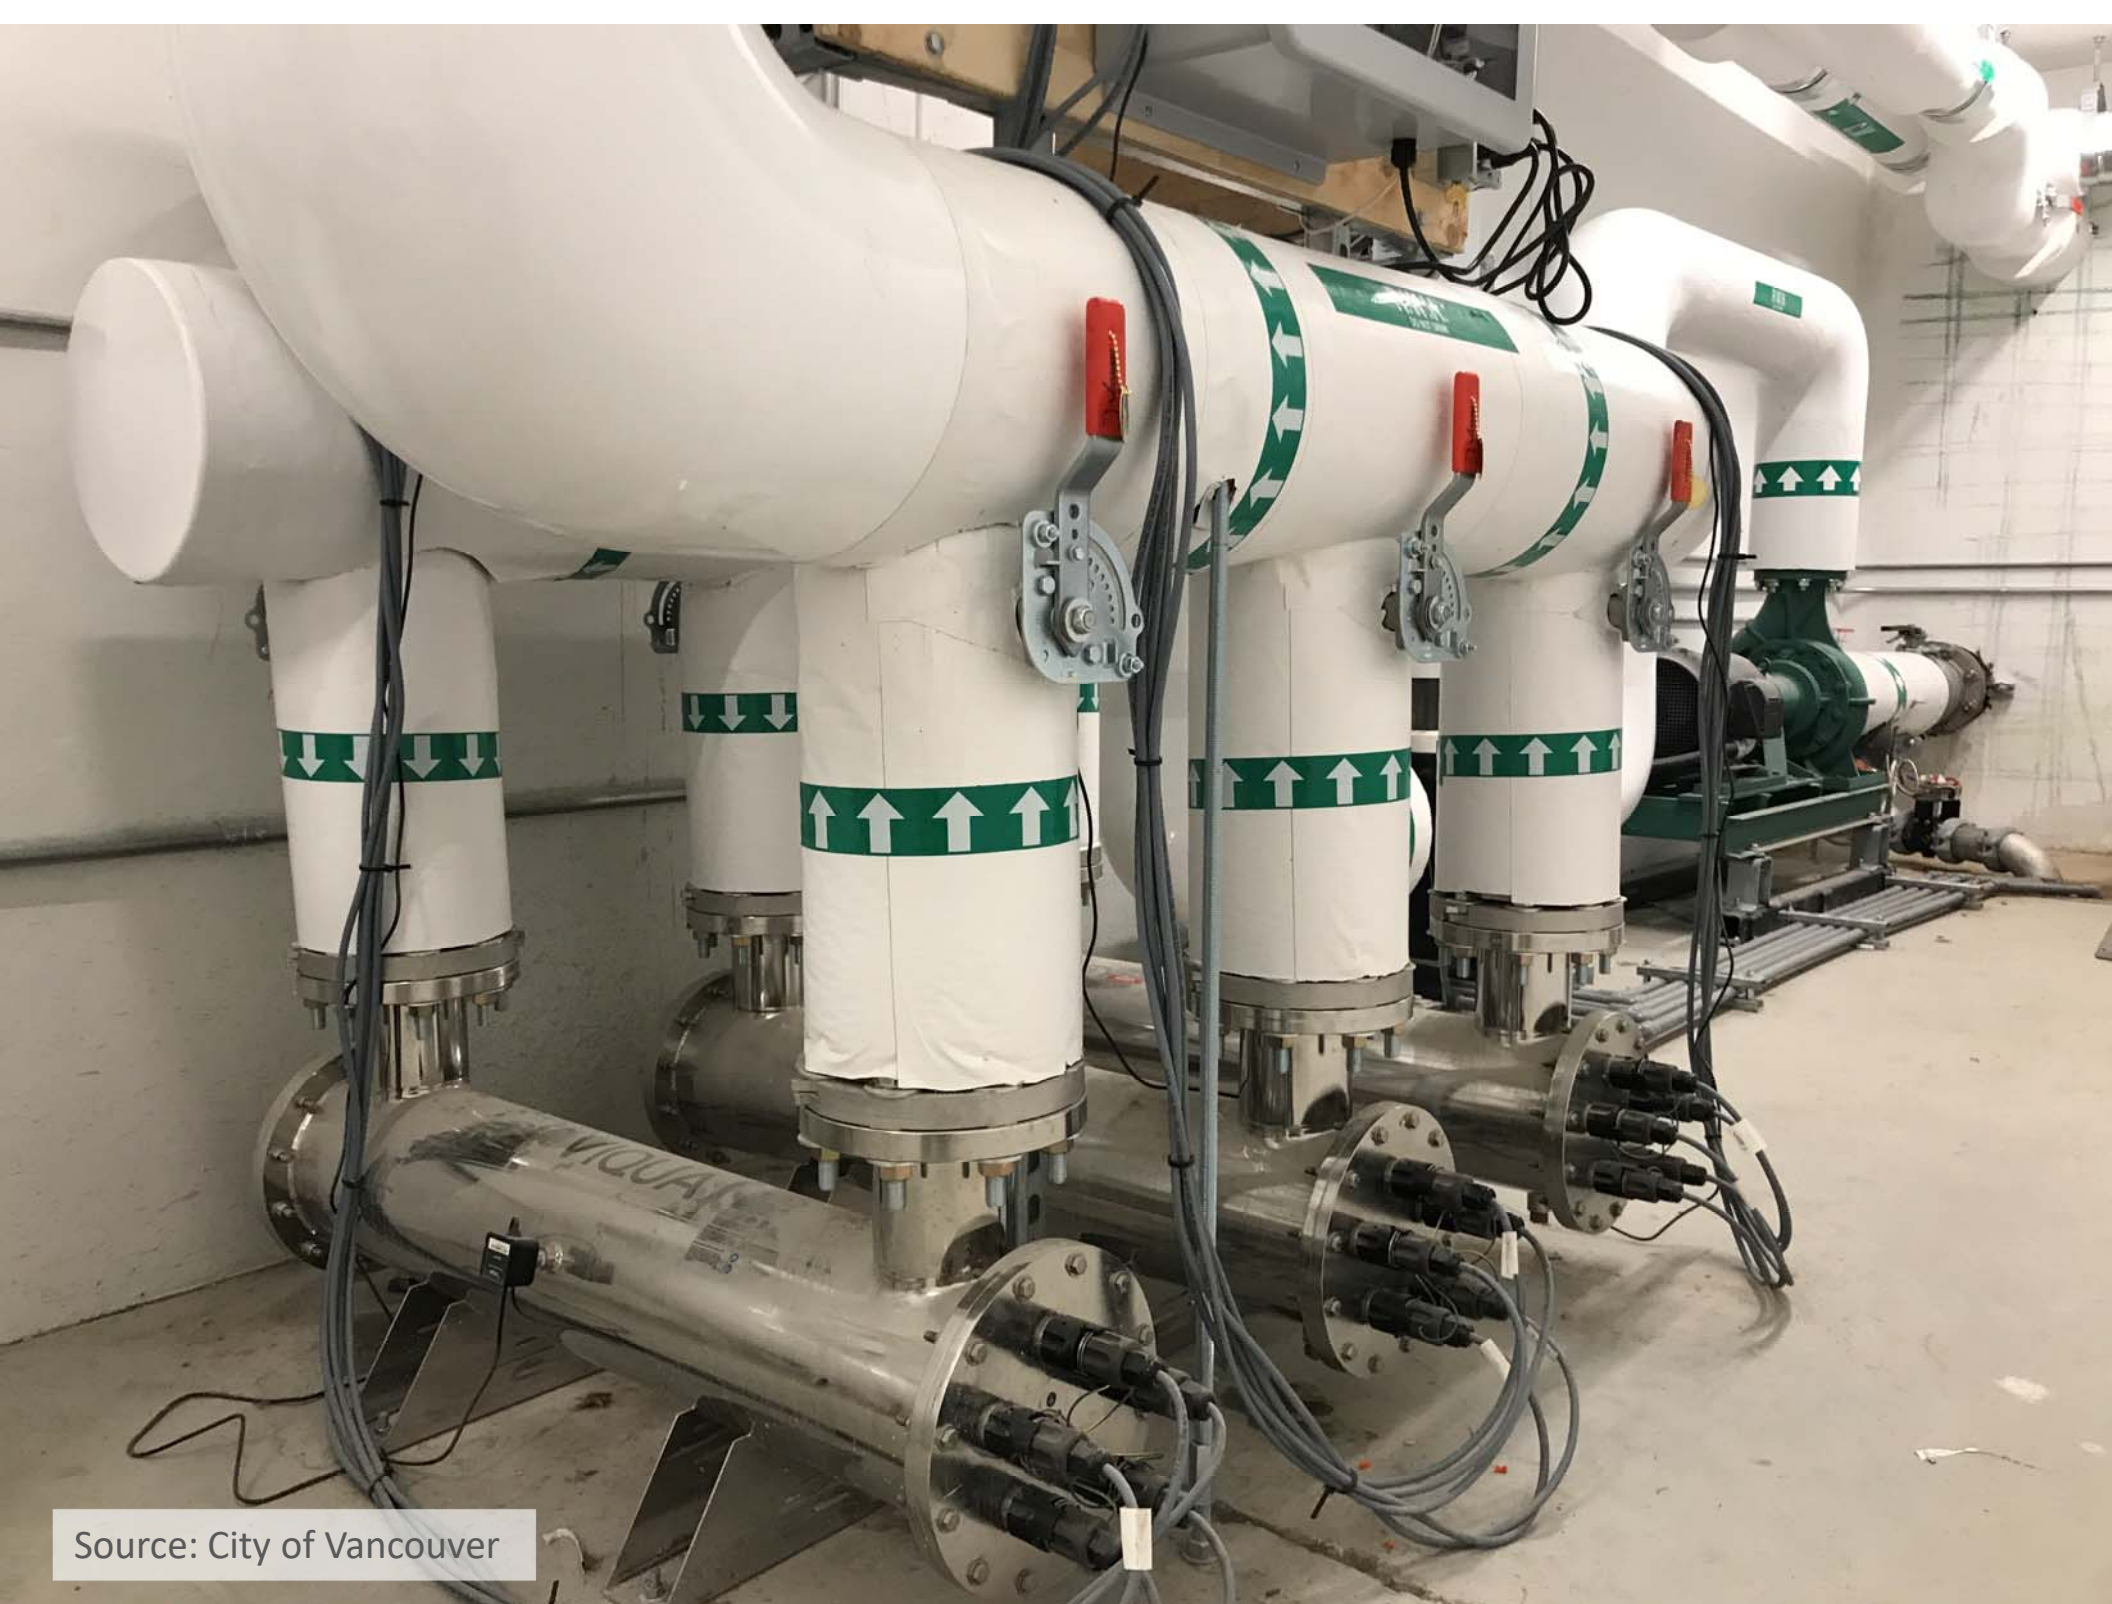
OP-2021-00151: Issued (Rainwater Harvesting/...
410 W GEORGIA STREET, Vancouver, BC V6B...

System Status	Sample/Report Date	Meets VBBL	System Maintained	Corrective Action	Legionella Conc.	E.coli Conc.	Turbidity
	Inactive	Jan 21, 2022	N/A	No	No			
	Active	Jan 27, 2022	Yes	Yes	No		<1	3.62
	Active	Feb 3, 2022	Yes	Yes	No		<1	14.70
	Active	Feb 10, 2022	Yes	Yes	No		<1	6.10
	Active	Feb 17, 2022	Yes	Yes	No	<10	<2	4.57

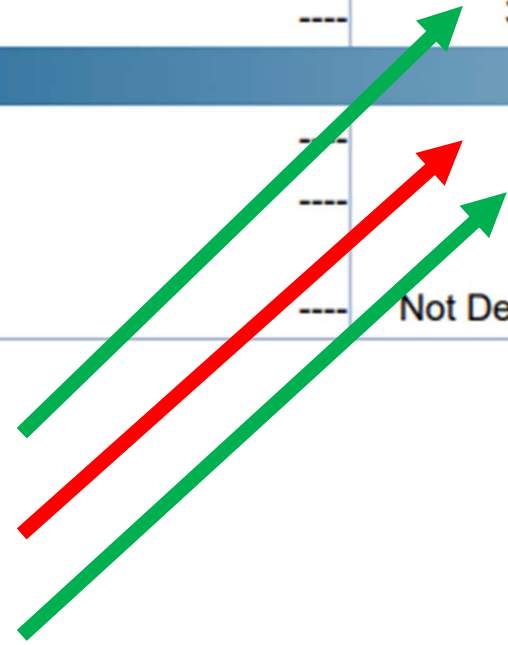
Analyte	CAS Number	Result
Physical Tests		
turbidity	----	3.83
Microbiological Tests		
Legionella pneumophila	---	10
coliforms, Escherichia coli [E. coli]	----	<1
Legionella, non-pneumophila	----	Not Detected

Turbidity < 10 NTU

L. pneumophila = 10 CFU / mL

E. coli < 100 CFU / 100 mL
